City of Encinitas

Level 3 Assessment of Blue Gum Tree

Near 1717 N Vulcan Ave

Asset I.D. # 8281ETREE

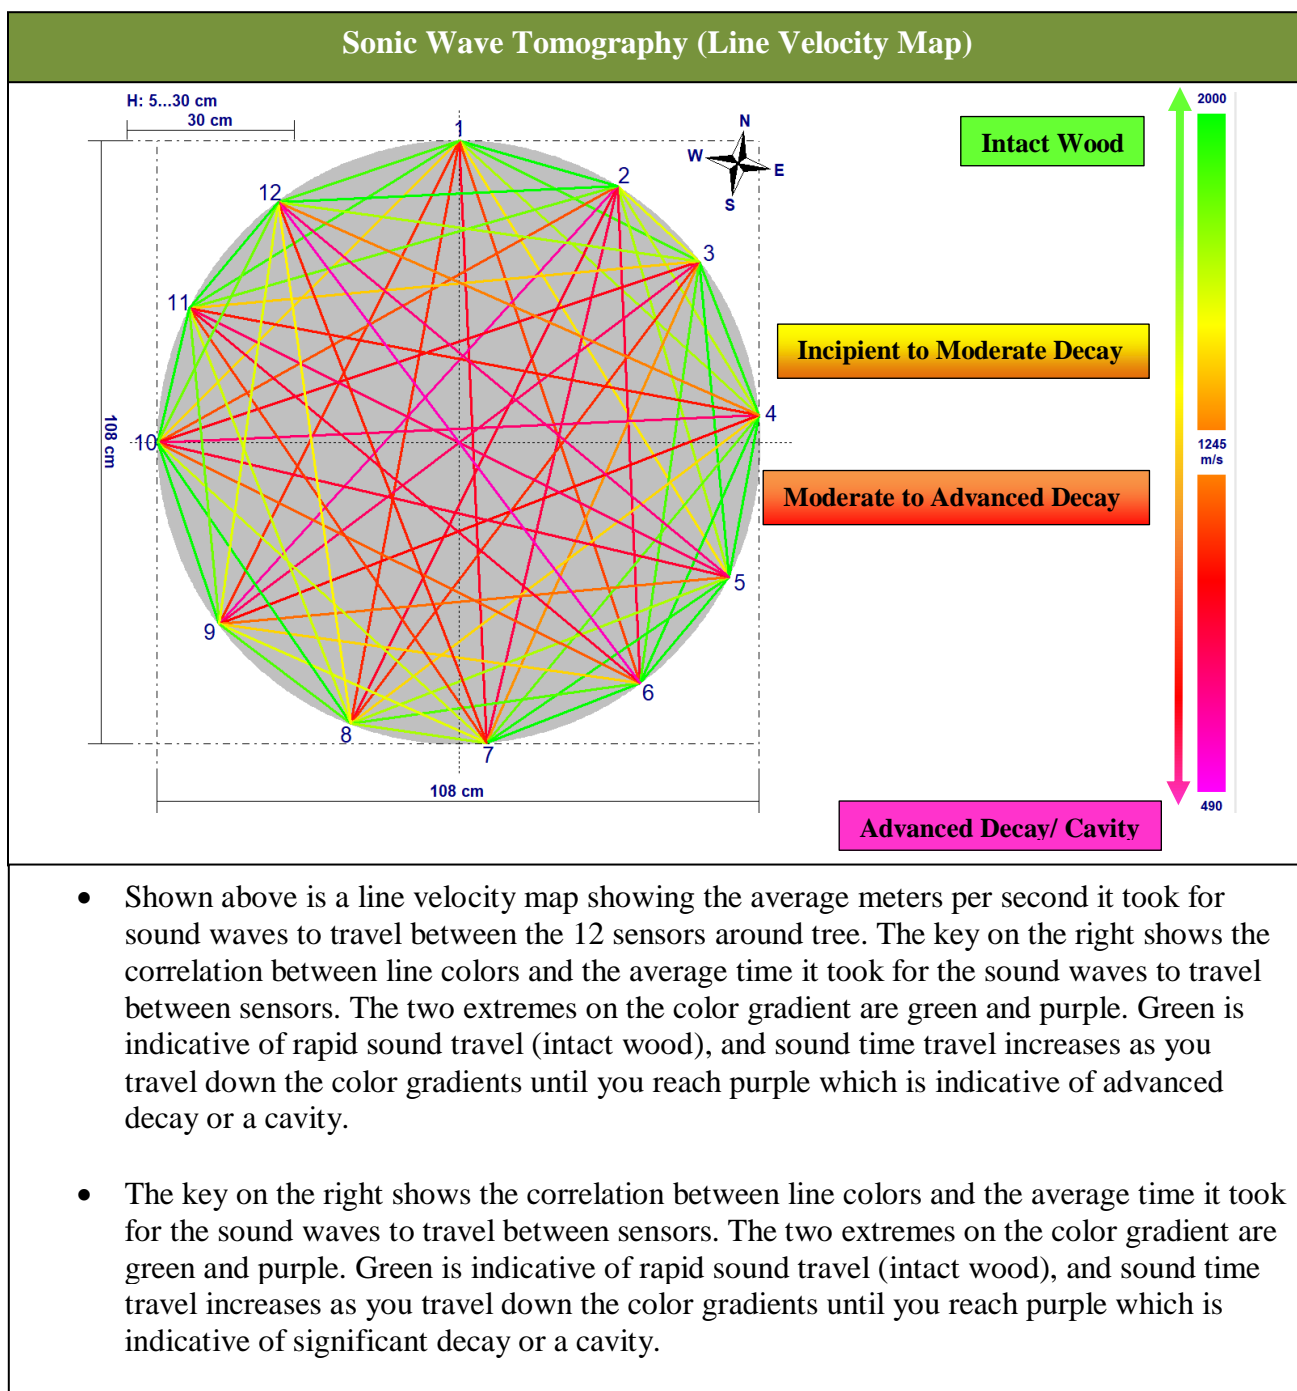
After completing the advanced trunk assessment, the defect of greatest concern was the indication of basal decay (see Appendix B) that likely extended further down into structurally important roots. This decay can significantly compromise the strength and elasticity of the wood which can lead to unpredictable failures. The *likelihood of failure* because of basal/ root decay was assessed as **probable** within the next 2 years if no mitigation is taken.
